MARINE SAFETY ADVISORY NO. 112-11

Subject: MALFUNCTION OF PROXIMITY SWITCH (MAIB SAFETY BULLETIN 2/2011)

MAIB SAFETY BULLETIN 2/2011

Malfunction of a proximity switch, which resulted
in failure of a fall wire with the loss of one life
on the car carrier *Tombarra*

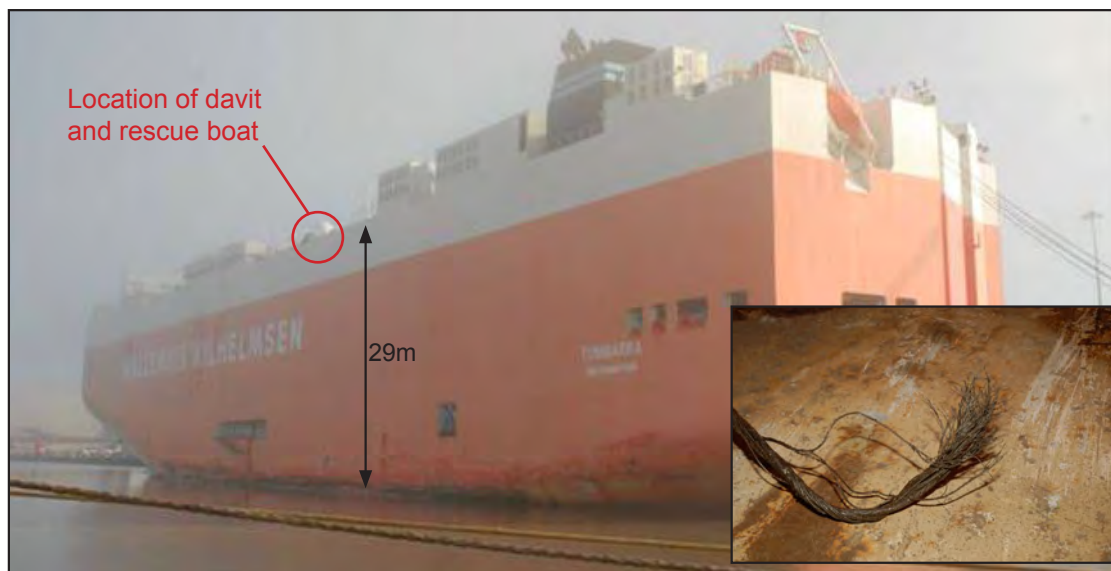
Figure 1

At approximately 1550 (UTC) on 7 February 2011, the fall wire of the rescue boat on board the UK registered car carrier *Tombarra* parted when the vessel was alongside in Royal Portbury Docks, Bristol, UK. The accident occurred as the rescue boat reached its stowed position on the davit following a monthly drill. Hoisting was not stopped before the davit reached its stowed position. The proximity switch, that should have cut electrical power to the winch motor before the davit reached its stops, failed to function. The rescue boat and its four crew fell nearly 29m (**Figure 1**) into the water below. One of the boat's crew died and two were hospitalised.

Vessel and parted fall wire

The 12mm diameter fall wire had a certified minimum breaking load of 141kN. Its safe working load (SWL) was 23.5kN based on a factor of safety of six. The wire was fitted to a single-arm davit (SA 1.5) (**Figure 2**), manufactured by Umoe Schat-Harding Equipment AS (Schat-Harding). The davit system was powered by a Schat-Harding W50 two-speed electric winch with a nominal pull of 50kN.

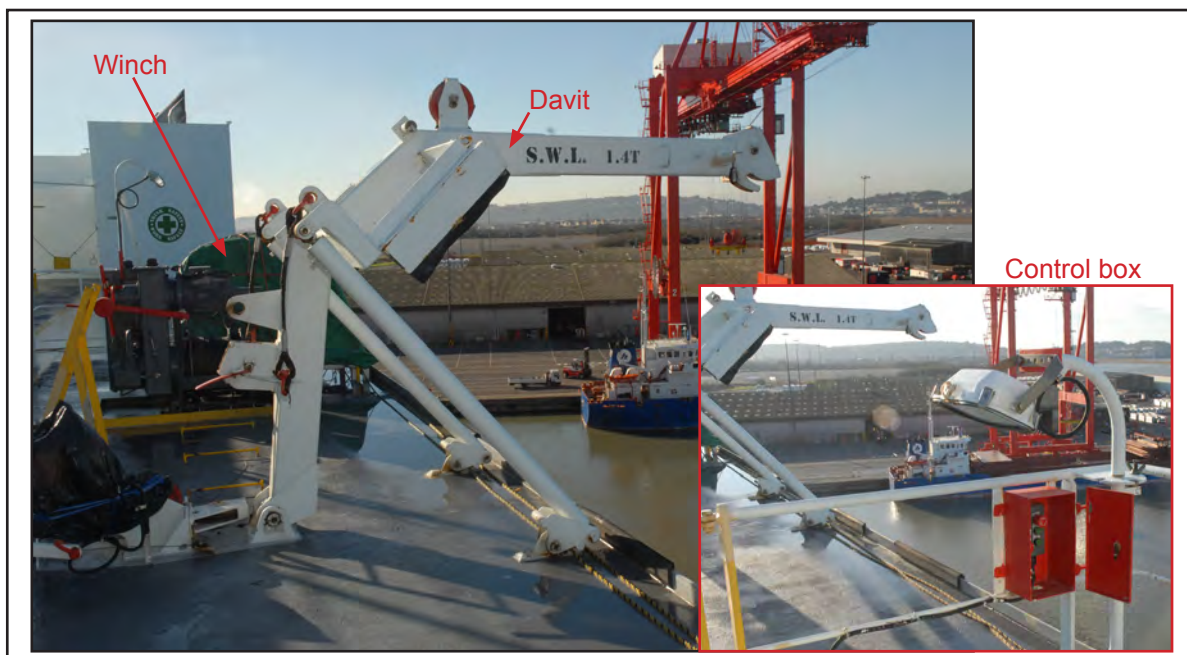
Figure 2

Davit system

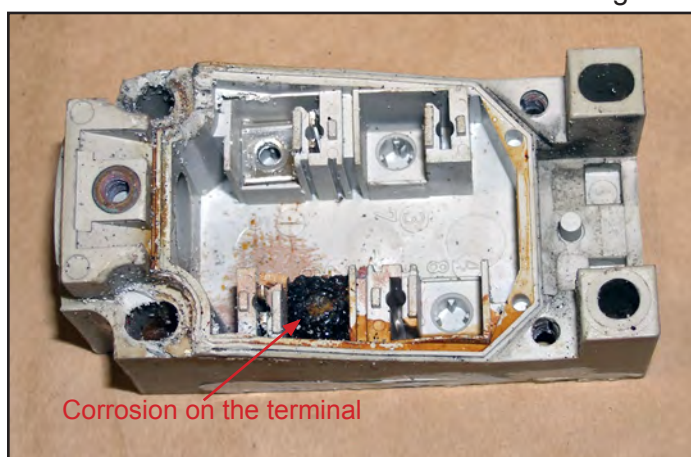
Figure 4

The terminal within the proximity/limit switch was found to be corroded.

The fall wire was observed to be in good condition and when tested after the accident it achieved a breaking load of 137kN. The wire parted near the lower most davit sheave as the rescue boat reached its stowed position and the winch was still hoisting under power. Although the winch motor was rated with a nominal pull of 50kN, the maximum pull that it was capable of exerting when trying to overcome the increased resistance in the system during the final stages of hoisting would have rapidly exceeded the breaking load of the wire. The proximity switch, which should have prevented this situation from occurring, was tested in situ and was found to be defective.

Corrosion on the terminal

Water ingress into proximity switch

The switch was installed in 2006, and prior to the accident it was not tested before hoisting was commenced. Inspection identified that the switch body had been penetrated by water (**Figure 4**). However, detailed analysis highlighted that the switch malfunctioned due to an unrelated electronic fault. The MAIB is aware of both inductive proximity and mechanical limit switches fitted on other vessels that have also failed to operate correctly. However, none are known to have resulted in a similar accident.

1. in cases where Schat-Harding SA 1.5 or Schat-Harding SA 1.75 davits are fitted, follow and implement the manufacturer's instructions;
2. ensure that all proximity/limit switches fitted to boat davit systems are tested on each occasion before a boat is hoisted and that such devices are not relied upon during operation;
3. follow manufacturers' recommendations regarding the maintenance and periodic testing, examination and replacement of proximity/limit switches used on lifeboat and or rescue boat davit systems and seek clarification from manufacturers where ambiguity exists; and
4. verify the effectiveness of seals on electrical equipment fitted to boat davit systems on open decks.

Schat-Harding has issued a Product Awareness Notice (PAN) to its customers highlighting the need to test the proximity switches fitted on its SA 1.5 and SA 1.75 davits on each occasion before hoisting operations commence, and recommends that the proximity switch is replaced every 2 years; it also highlights the need for caution when using pressure washers on deck.

- In the case of vessels fitted with the Schat-Harding SA 1.5 and SA 1.75 davits, follow the advice contained in the PAN recently issued by the manufacturer or urgently contact Schat-Harding¹ if a PAN has not been received.
- Ensure that all devices (inductive or mechanical) fitted to boat davit systems to prevent overload are tested on each occasion before a boat is hoisted and that such devices are not relied upon during operation.
- Follow manufacturers' recommendations regarding the maintenance and periodic testing, examination and replacement of safety devices, seeking clarification from manufacturers where ambiguity exists.
- Verify the effectiveness of watertight seals on electrical equipment fitted to boat davit systems on weatherdecks.
